# Pier E2 Anchor Rods

- A number of S1 and S2 shear key anchor rods at pier E2 have failed after tensioning.
- Rods were tensioned in between March 1 and March 5.
- Broken rods were discovered between March 8 and March 15.
- Failed rods manufactured in Ohio in 2008 and installed in Pier E2 pier table in late 2008.
- Remaining rods have been untensioned pending resolution of problem.
- Caltrans currently performing tests to determine cause and designing fix to problem.

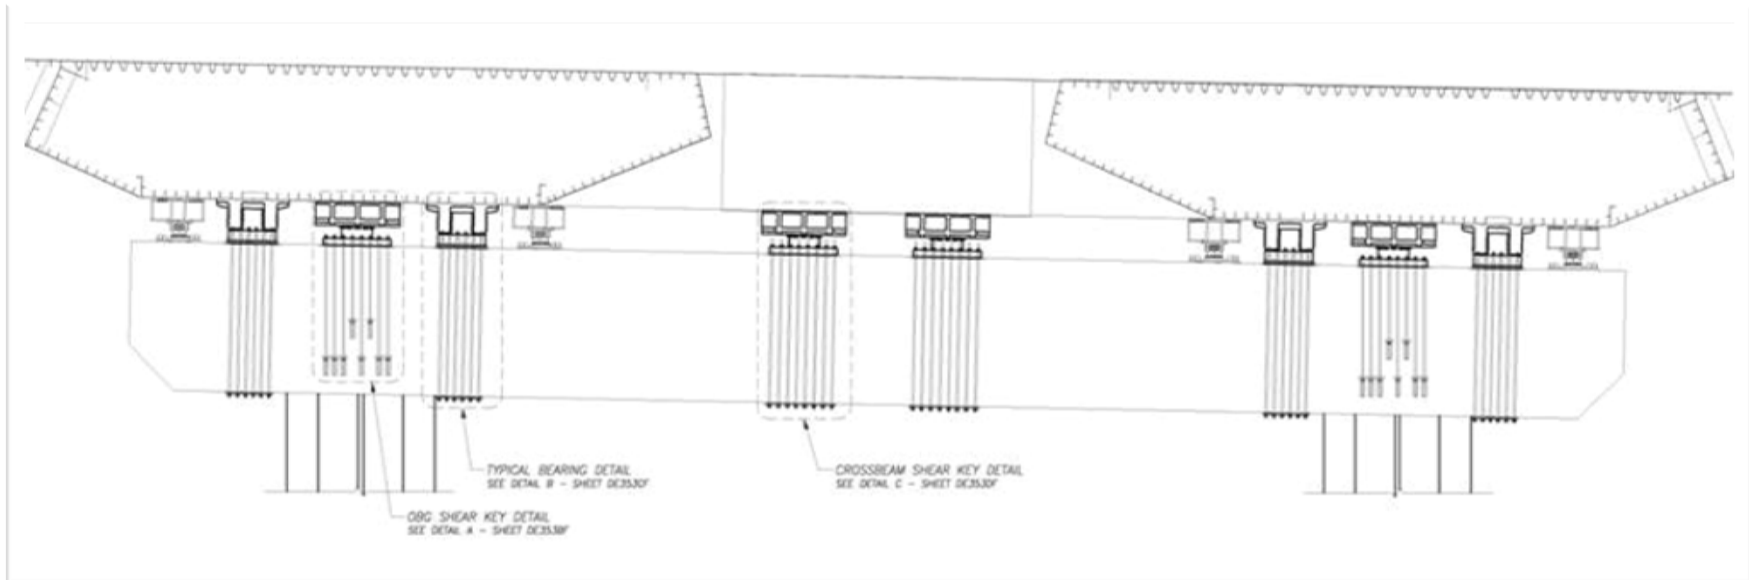
- In total, there are 4 bearings and 4 shear keys
- Anchored rods have failed at S1 and S2 shear keys
- Other rods for remaining bearings and shear keys were manufactured later and will undergo testing.

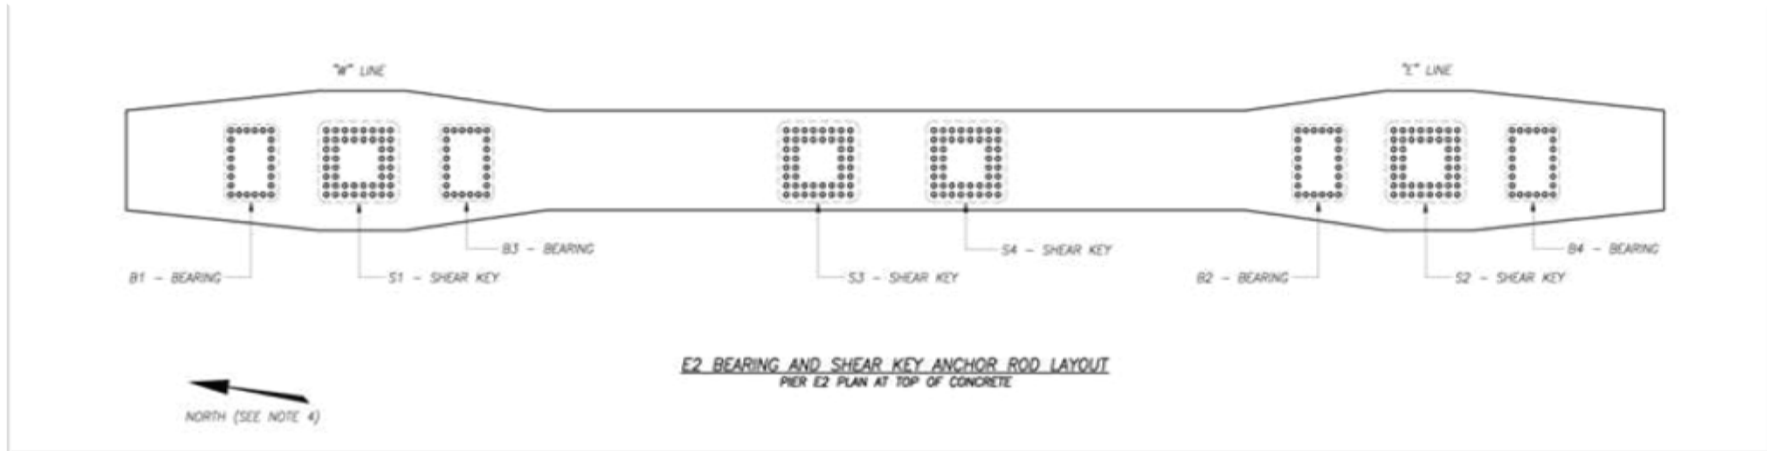
- Bearings and shear keys are secured to E2 by 3" diameter anchor rods
- Each bearing has 24 anchor rods and each shear key has 48 anchor rods for a total of 288 anchor rods to be stressed
